No. 2016/M(N)/951/28 (E-3323079)

Sub: Review of Codal Life of BRN Variant Wagons
Ref: RDSO letter MW/BRNA dated 24.12.2024

No. MW/BRNA

Sub: Review of Codal Life of BRN Variant Wagons, Case of Centre Sill Parting from Bolster.

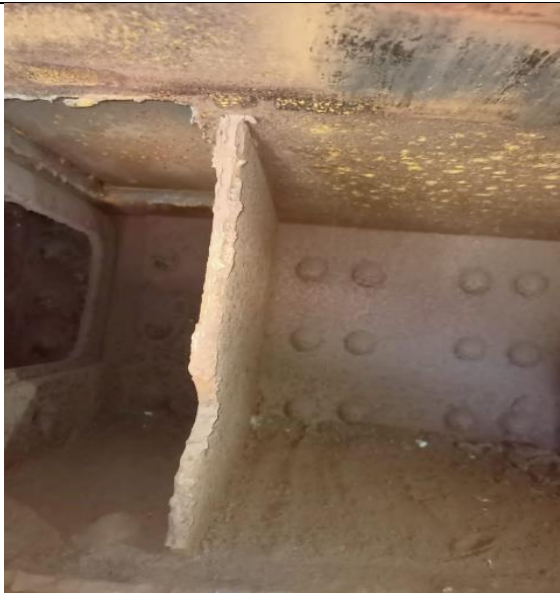
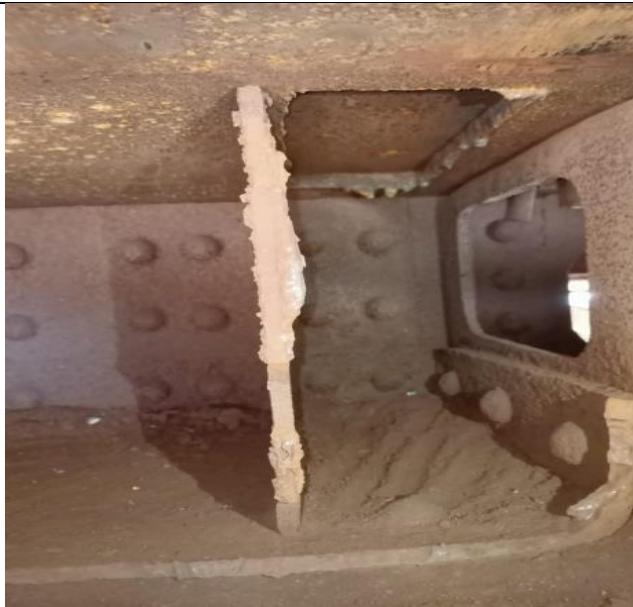
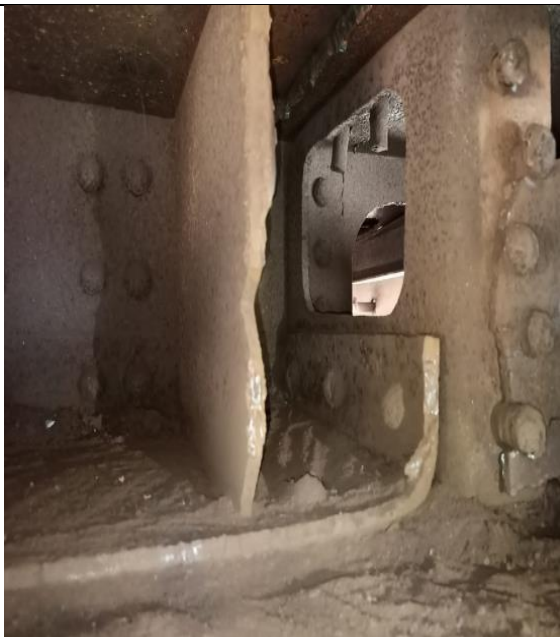
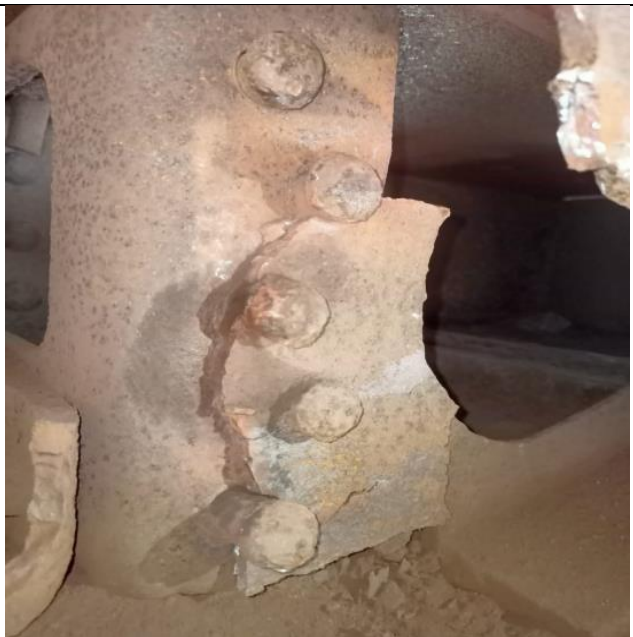
S.No.	<u>WAGON Detail</u>	<u>Defects observed by RDSO</u>
1.	<p>SER 55079160537</p> <p>Train parting in SBC Division on 24.02.2022 due to working out of Bolster Centre Pressing of BRN wagon.</p> <p>(i) South Western Railway letter no. 2012/M (N)/951/35 dated 11.03.2022.</p> <p>(ii)SECR letter no. Mech./HQ/008/008/306 dated 02.03.2022.</p>	<p>SECR informed a train parting of train no. PLMD (Loaded BRN wagons) of South Western Railway due to broken bolster centre pressing of wagon no. SER 55079160537. During joint investigation, it was found that the train parting took place due to leading end bolster centre pressing having old crack to the extent of about 80% on the inner side and Bolster centre pressing was found in completely sheared condition from centre sill.</p>

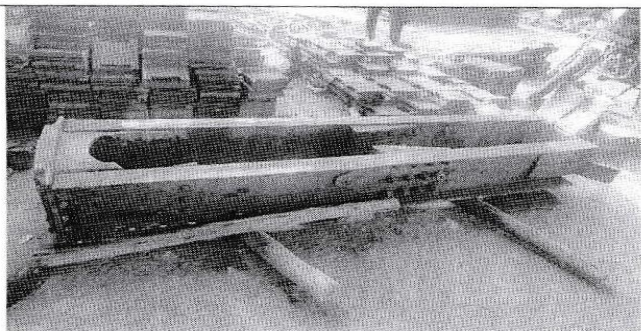
CBC assembly already removed by gas cut at Sick line of Raigarh. Back stop rivets found intact. Striker casting not affected.

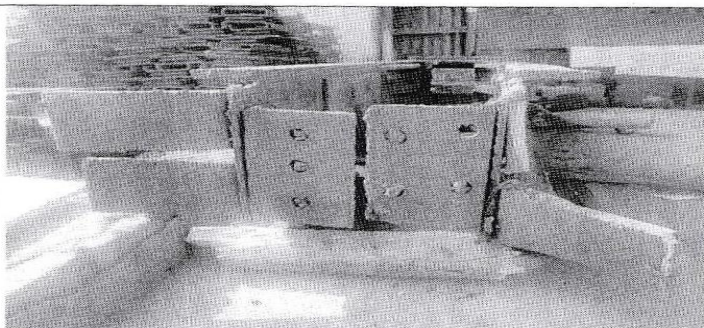
Inside knee flange edges weld with Web of Bolster also plug welded. Plug weld found rusty. Hence plug weld already failed.

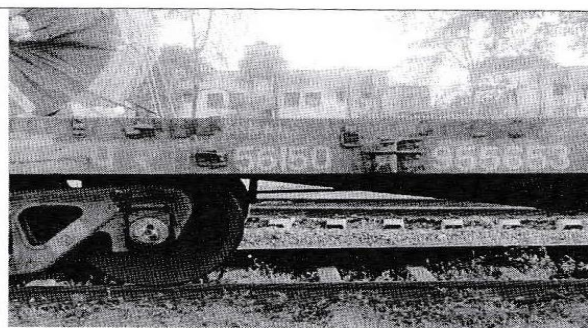
Affected BRNAHS Wagon no. 56150955653 at Raigarh (Bilaspur Division-South East Central Railway)

S.No.	Train Detail	Defects observed
04	<p>Train no.: CON-KAV, ex-TATA (Rear rake) Loco no.-43499 BPC-50000656648, TATA, 05.05.24, INTENSIVE (93.10%) Culprit wagon details Wagon no.-SWR 56150955653 BRNAHS (R-09/24) Manufacturing date: 22.05.2009 (M/s Burn Standard Co. Ltd.) 1st POH- 03.08.2015 (RWS) 2nd POH- 26.02.2020 (RWS) Last ROH-22.11.2023 (GIM)</p>	<p>Following observations have been made by checking culprit wagon at site by Workshop supervisors:• Centre sill assembly along with CBC items was found work out from Bolster joint.</p> <ul style="list-style-type: none"> • All CBC items were found in good condition. • Hand Brake was found in applied condition and J-bracket of hand brake was in broken condition. • This wagon was attached in a rake which was in long Haul operation without DPWCS system

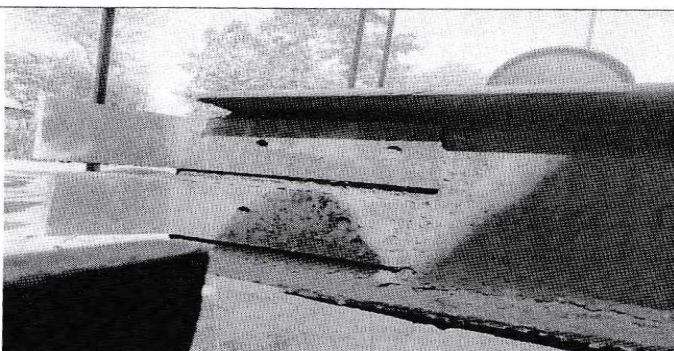
Outer knee found intact with End longitude

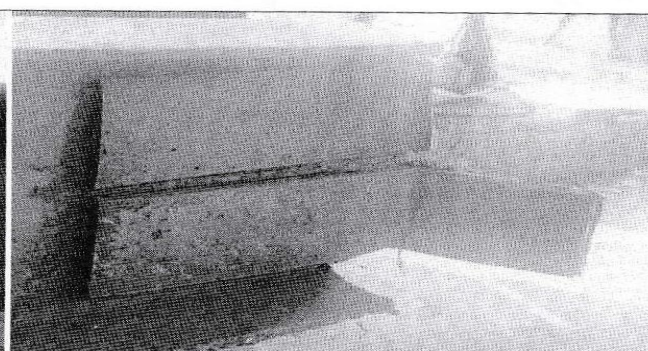
Outer knee found intact with other End longitude
