2. Root cause analysis of the accident –

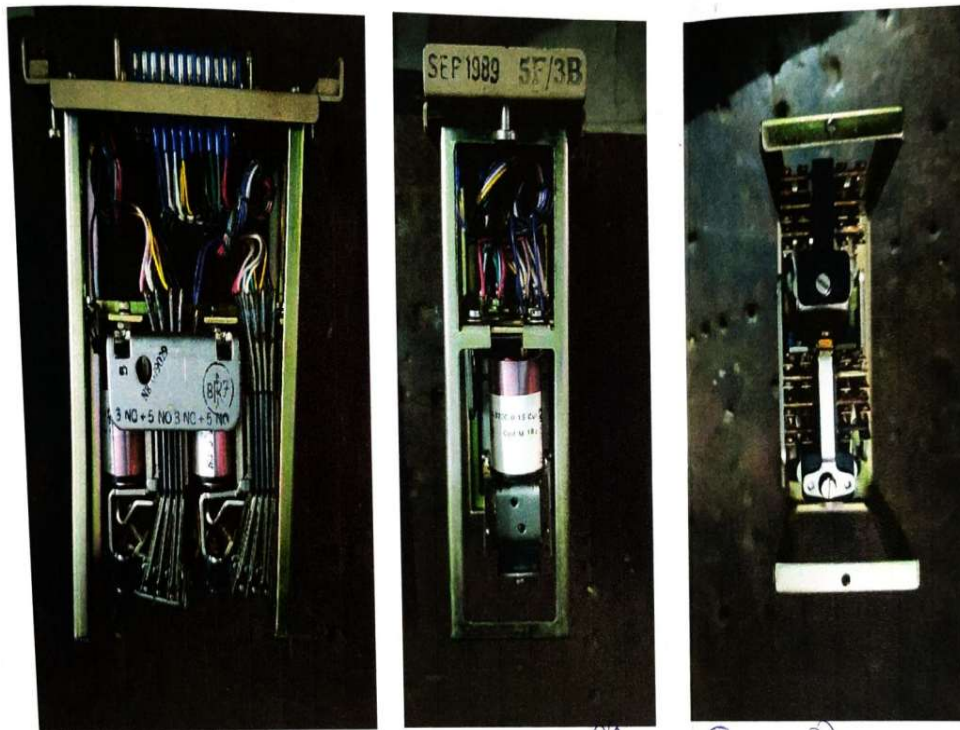
26 WRR K-50 Relay

- (iv) During enquiry, the night signal maintainer confessed that during his attempt to fix the failure of S-10, he stooped down to see the condition of 10 NNR relay (Q series) on relay rack #2 and ***while standing up, he casually rubbed the K-50 Siemens latch relay for point no. 26 installed on relay rack #1.*** The relay rack #2 and relay rack #1 are facing each other hardly 84.5 cm apart.

- (v) On inspection of relay room at Nalpur, it was discovered that ***out of two screw provided for holding such relay on relay rack, only one top screw was tightened up and no bottom screw was provided which was required to fix it firmly and hold the relay tightly.*** This missing provision of bottom screw have ***led to this original relay swinging and while hitting when restores to its position led to detaching of the relay K50 for point no. 26B from its normal to reverse position.*** The details of culprit relay K-50 for point no. 26B was- SI no- 8070909, Configuration – 5F/3B, ***Manufactured in the year – Sep'1989.***

- (ii) During the inquiry, it has come to light that the ***Point Control Circuit was not designed to prevent unwarranted operation of a point in case of its K50 (Siemens Make)*** mechanical relays malfunctioning and making way for other operations of the point. ***Thus there was some short coming in the design of such mixed type of relay system which existed at Nalpur (i.e., mixture***

- (iv) The K-50 relay used for point no. 26B was of manufacture in the year Sep/1989, whereas PI at Nalpur was commissioned in March/1999. So, this relay has already outlived considerable period of its life (around 10 yrs) at the time of the commissioning of the system. **So, It should be ensured that equipment being installed should not be much older (not more than 2 years) at the time of commissioning.**

- (vii) The **S&T sectional maintainer had been posted there since last 21 years but he failed to notice that the K-50 relay for Point No. 26B was on loose condition though this is a part of his duty(as per IRSEM 3.8) to check it once in a month.** He also failed to notice that neither bottom screw nor holes for fixing this screw on relay rack was available which **led this relay to swing while hitting.**

- (iii) Being panel interlocking of Q-series relays, K-50 mini group and minor group have been used for point operations at this station. **So at all such stations, the existing point operation circuits using K-50 mechanically latched relay should be replaced using QL1 magnetically latched relays.**
