No. 2016/M(N)/951/28 (E-3323079)

Sub: Review of Codal Life of BRN Variant Wagons
Ref: RDSO letter MW/BRNA dated 24.12.2024

No. MW/BRNA

Sub: Review of Codal Life of BRN Variant Wagons, Case of Centre Sill Parting from Bolster.

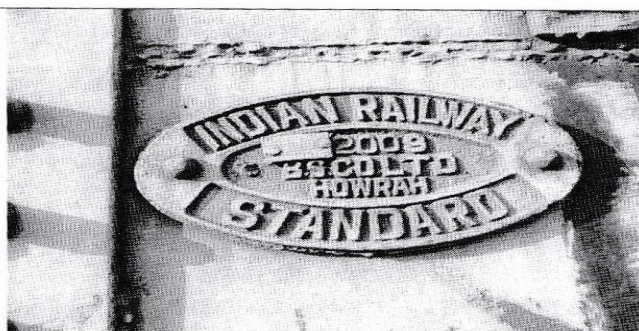
CBC assembly already removed by gas cut at Sick line of Raigarh. Back stop rivets found intact. Striker casting not affected.
